**Flood Control Project Maintenance
Levee Inspections**

Maintenance Issue Types Only, Levee Inspection Report By Mile - Fall 2016

Reclamation District No. 2107 Mossdale Island

Waterway	Bank	Unit Miles	Inspection Start/End	Inspector
Unit No. 01 San Joaquin River	Left	2.33	10/05/2016 10/05/2016	Maksim Khashchuk

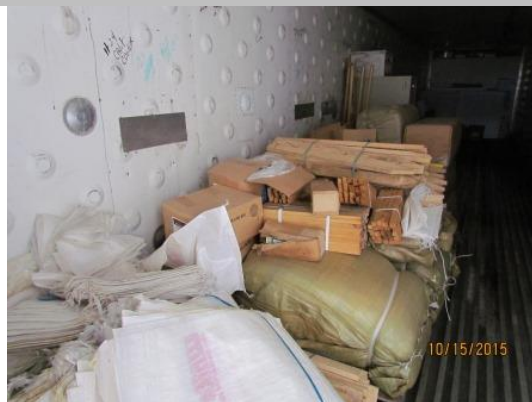
Photo 1 of 1 : FA_2016_RD2107_329_7_20160914_00003.jpg

LM Start		Rating **	A	Issue No.	7
LM End		Issue Type +	Ma	Location *	LS
Category	Earthen Levee		GPS Latitude/Longitude		
			Start	End	
Item	Emergency Supplies & Equipment				
DWR ID	DWR_RD2107_01_s_2013_7				
Comment Code					
Inspector Comment					
Flood fighting supplies are available on-site.

View of the flood fight emergency supplies.

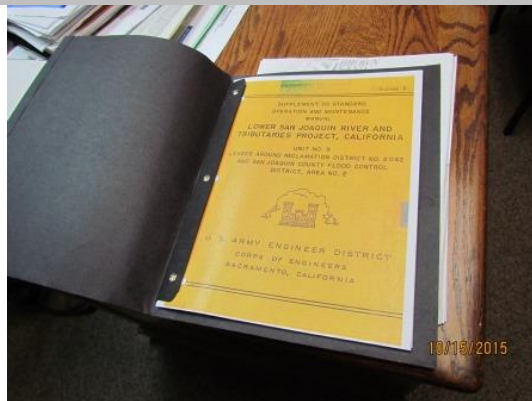
Photo 1 of 1 : FA_2016_RD2107_329_8_20160914_00004.jpg

LM Start		Rating **	A	Issue No.	8	
LM End		Issue Type +	Ma	Location *	LS	
Category	Earthen Levee			GPS Latitude/Longitude		
				Start		End
Item	Operations & Maintenance Manuals				°	
					°	
DWR ID	DWR_RD2107_01_s_2013_8					
Comment Code						
Inspector Comment						
The O&M Manual is available at the LMA's office.

View of the O&M Manual.

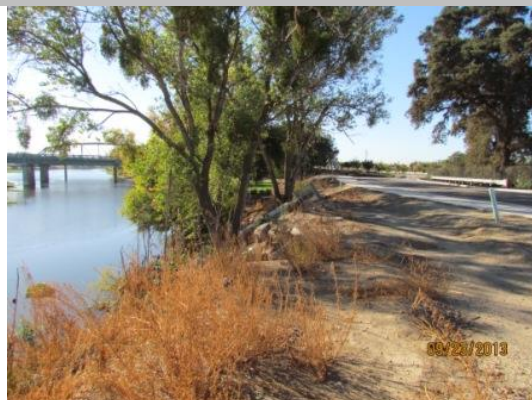
Photo 1 of 1 : FA_2016_RD2107_329_1_20160914_00001.jpg

LM Start	0.03	Rating **	N	Issue No.	1
LM End	0.03	Issue Type +	Ma	Location *	WS
Category	Earthen Levee			GPS Latitude/Longitude	
				Start	End
Item	Trim / Thin Trees			37.786993 °	37.786993 °
				-121.308694 °	-121.308694 °
DWR ID	DWR_RD2107_01_s_2012_1				
Comment Code					
T5 : Tree stumps.					
Inspector Comment

Photo of waterside slope. Stumps present from prior tree removal for access and visibility.

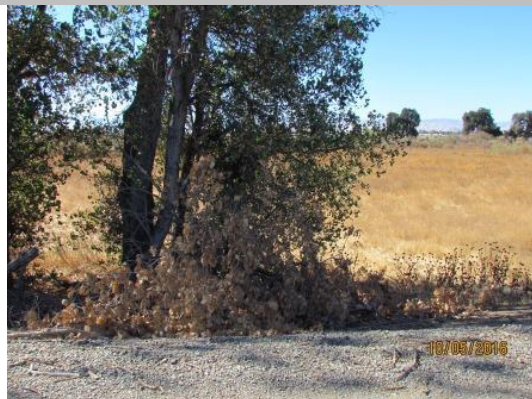
Photo 1 of 1 : FA_2016_RD2107_330_8_20161006_00012.jpg

LM Start	0.21	Rating **	M	Issue No.	8
LM End	0.21	Issue Type +	Ma	Location *	WS
Category	Earthen Levee			GPS Latitude/Longitude	
				Start	End
Item	Encroachments			37.761881°	37.761881°
				-121.312850°	-121.312850°
DWR ID	DWR_RD2107_02_f_2016_8				
Comment Code					
PR : Prunings					
Inspector Comment

View of the prunings of the waterside levee slope.

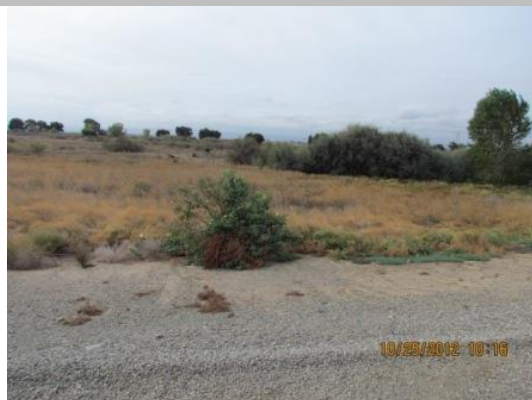
Photo 1 of 1 : FA_2016_RD2107_330_4_20160914_00001.jpg

LM Start	0.51	Rating **	A/W	Issue No.	4
LM End	0.51	Issue Type +	Ma	Location *	WS
Category	Earthen Levee			GPS Latitude/Longitude	
				Start	End
Item	Vegetation			37.764780 °	37.764780 °
				-121.316717 °	-121.316717 °
DWR ID	DWR_RD2107_02_s_2012_4				
Comment Code					
V4 : Elderberries are blocking visibility and flood fight capability.					
Inspector Comment					
Elderberry bush on waterside. Shrub is more than 20ft down the slope.

Elderberry located on waterside slope.

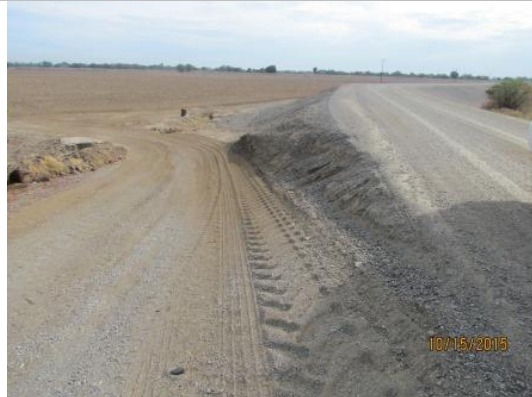
Photo 1 of 1 : FA_2016_RD2107_330_9_20160914_00002.jpg

LM Start	0.54	Rating **	M	Issue No.	9
LM End	0.54	Issue Type +	Ma	Location *	LS
Category	Earthen Levee			GPS Latitude/Longitude	
				Start	End
Item	Slope Stability			37.764838 °	37.764838 °
				-121.317318 °	-121.317318 °
DWR ID	DWR_RD2107_02_f_2015_9				
Comment Code					
S1 : Repair slope instability.					
Inspector Comment					
Add appropriate fill and compact the slope.

View of the vertical cut on the landside levee slope.
